# Manhole Inspection Summary

Manhole # S25UU1004MH

Insp Date: **5/3/07 4:00 PM**

**Location** Address: **5101 ROLAND AVE**

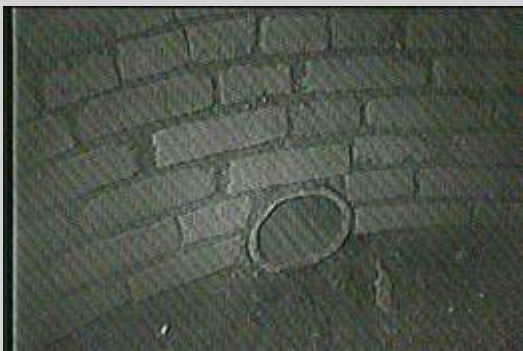
### 8 in. Circular Gravity Sewer Pipe In @ 4 O'Clock

Rod and Bar (Angled)

Pipe Material: **Clay** ☐ Pipe Lined

Infiltration: **None** Pipe Seal Cond: **Unknown**
